**Versailles Gardens I C.A.**  
**SIRS Components**  
***Miami, FL***

Report #: 51614-0  
Beginning: January 1, 2026  
Expires: December 31, 2026

**RESERVE STUDY**  
**"Full"**

May 20, 2025

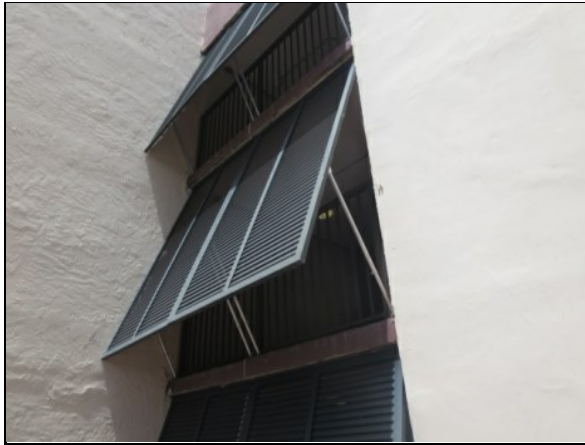
**Comp #: 2359 Metal Awnings/Shutters - Replace****Approx Quantity: 12 Awnings/Shutters****Location:** Building exteriors**Funded?:** Yes.**History:****Comments:** Approximate Count/Measurements -  
(12) 10-ft by 8-ft

**Useful Life:**  
30 years

**Remaining Life:**  
23 years
