**Versailles Gardens I C.A.**  
**SIRS Components**  
***Miami, FL***

Report #: 51614-0  
Beginning: January 1, 2026  
Expires: December 31, 2026

**RESERVE STUDY**  
**"Full"**

May 20, 2025

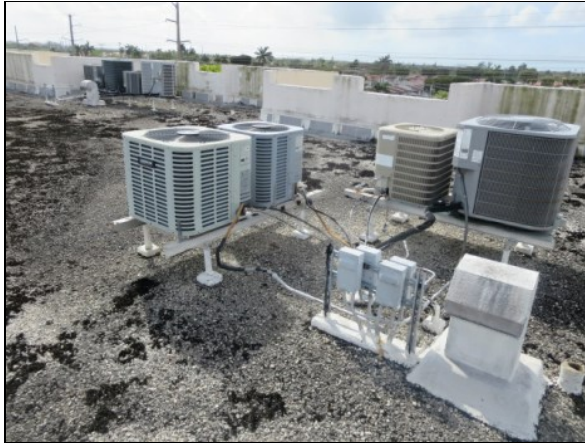
**Remaining Life:**

3 years

**Lower Estimate:** \$ 202,000**Higher Estimate:** \$ 246,000**Cost Source:** AR Cost Database

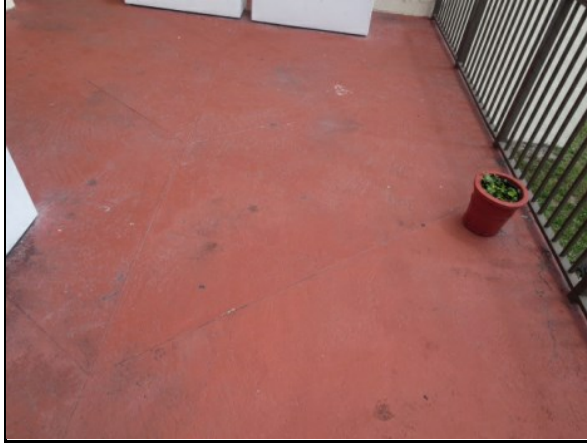
**Remaining Life:**

3 years

**Lower Estimate:** \$ 99,000**Higher Estimate:** \$ 121,000**Cost Source:** AR Cost Database

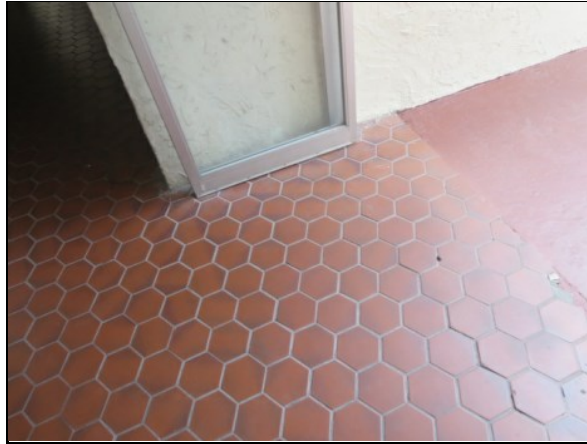
**Remaining Life:**

3 years

**Lower Estimate:** \$ 365,000**Higher Estimate:** \$ 447,000**Cost Source:** AR Cost Database

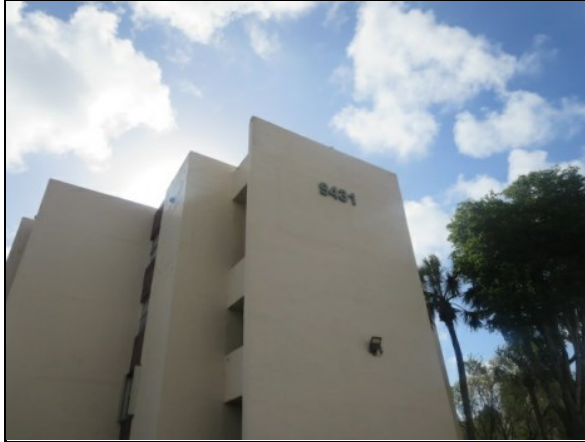
**Remaining Life:**

3 years

**Lower Estimate:** \$ 460,000**Higher Estimate:** \$ 562,000**Cost Source:** AR Cost Database

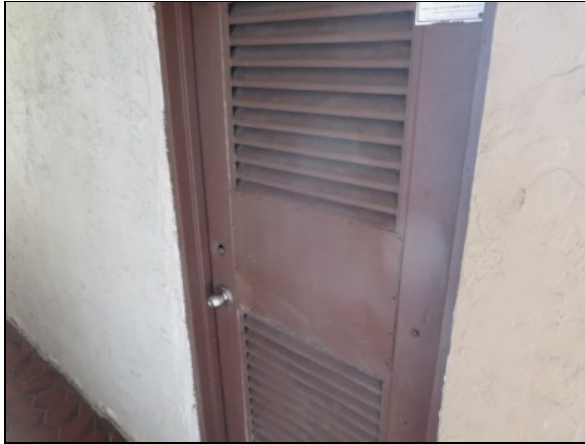
**Remaining Life:**

3 years

**Lower Estimate:** \$ 218,000**Higher Estimate:** \$ 267,000**Cost Source:** AR Cost Database

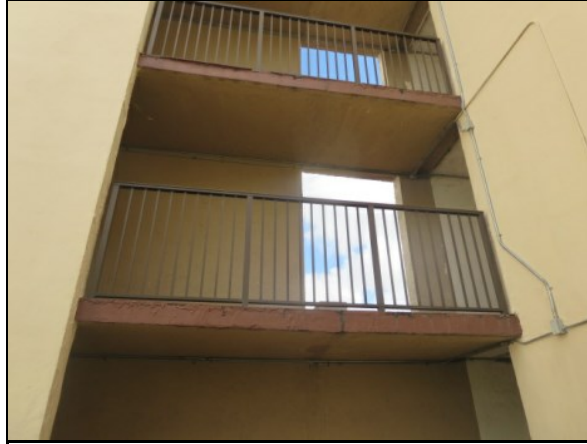
**Remaining Life:**

23 years

**Lower Estimate:** \$ 159,000**Higher Estimate:** \$ 194,000**Cost Source:** AR Cost Database
